Troubleshooting

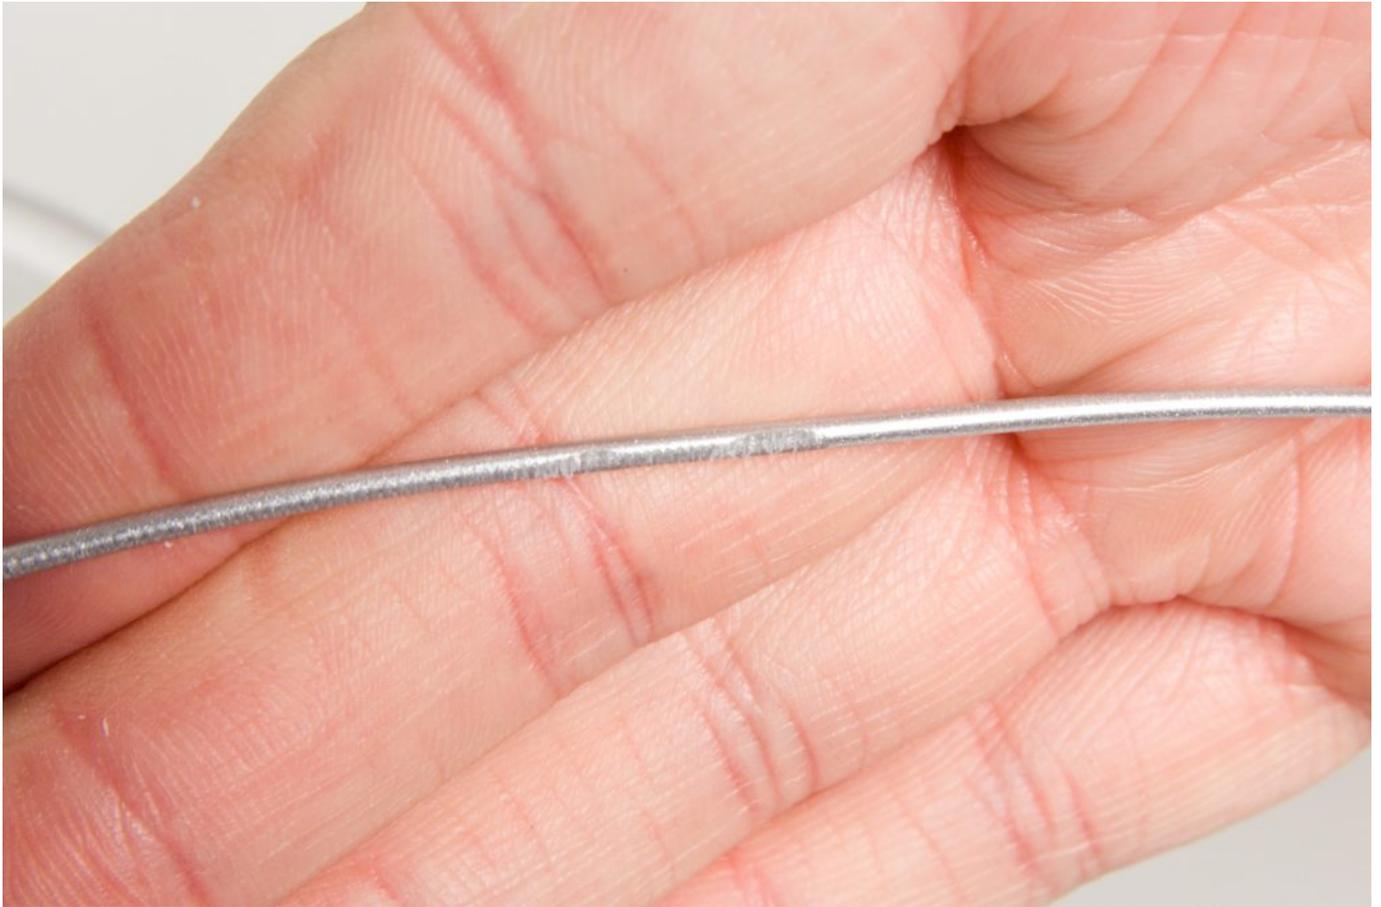
The Filament is Planed off Within the Extruder's Feeder

If the filament is not being moved towards the print head during the extruder's motion, the problem probably lies in an incorrect tensioner adjustment or a clogged nozzle. This problem can be accompanied with a clattering sound, and planed-off filament will appear nearby the feeder wheel. Clean and/or exchange the nozzle. Perform the "cold pull" nozzle cleaning procedure or exchange the nozzle.

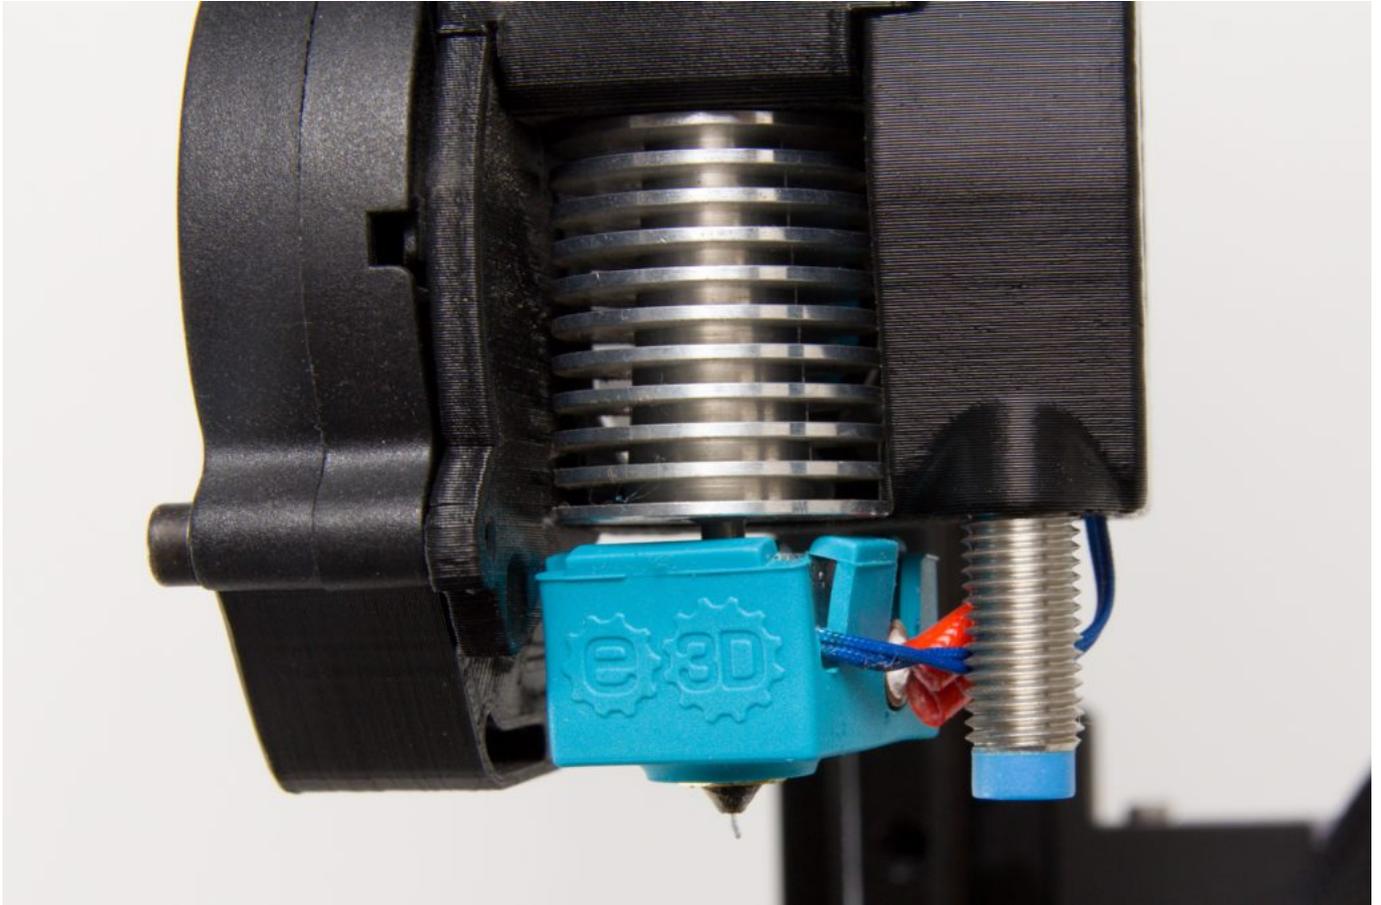
The Hot End Has Been Rotated

Follow the steps from Filament Is Leaking Over the Heat Block above. After removing the hot end, straighten the block's rotation and place the hot end back into the print head using the same instructions.

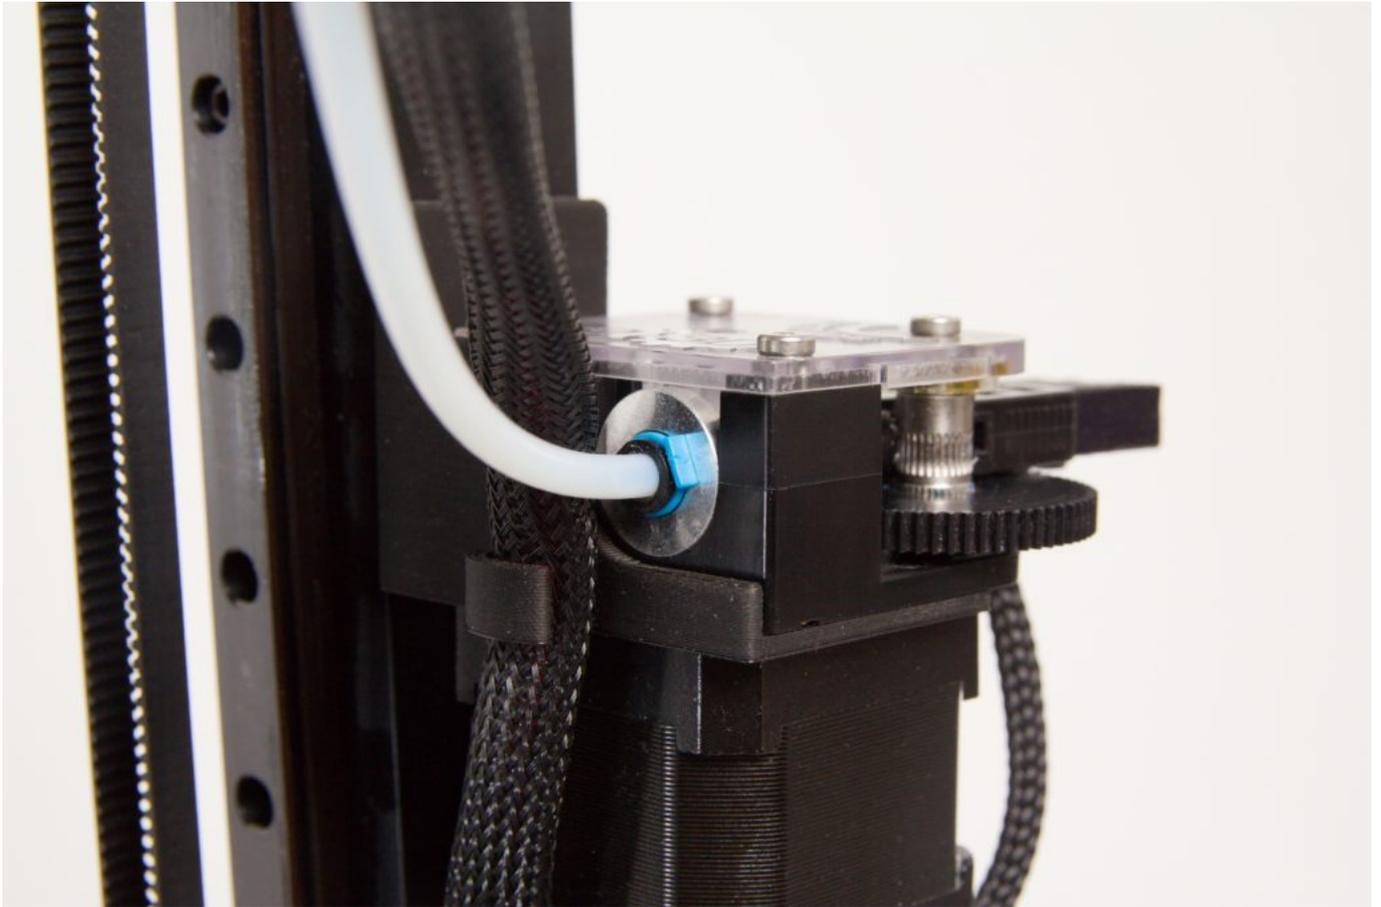
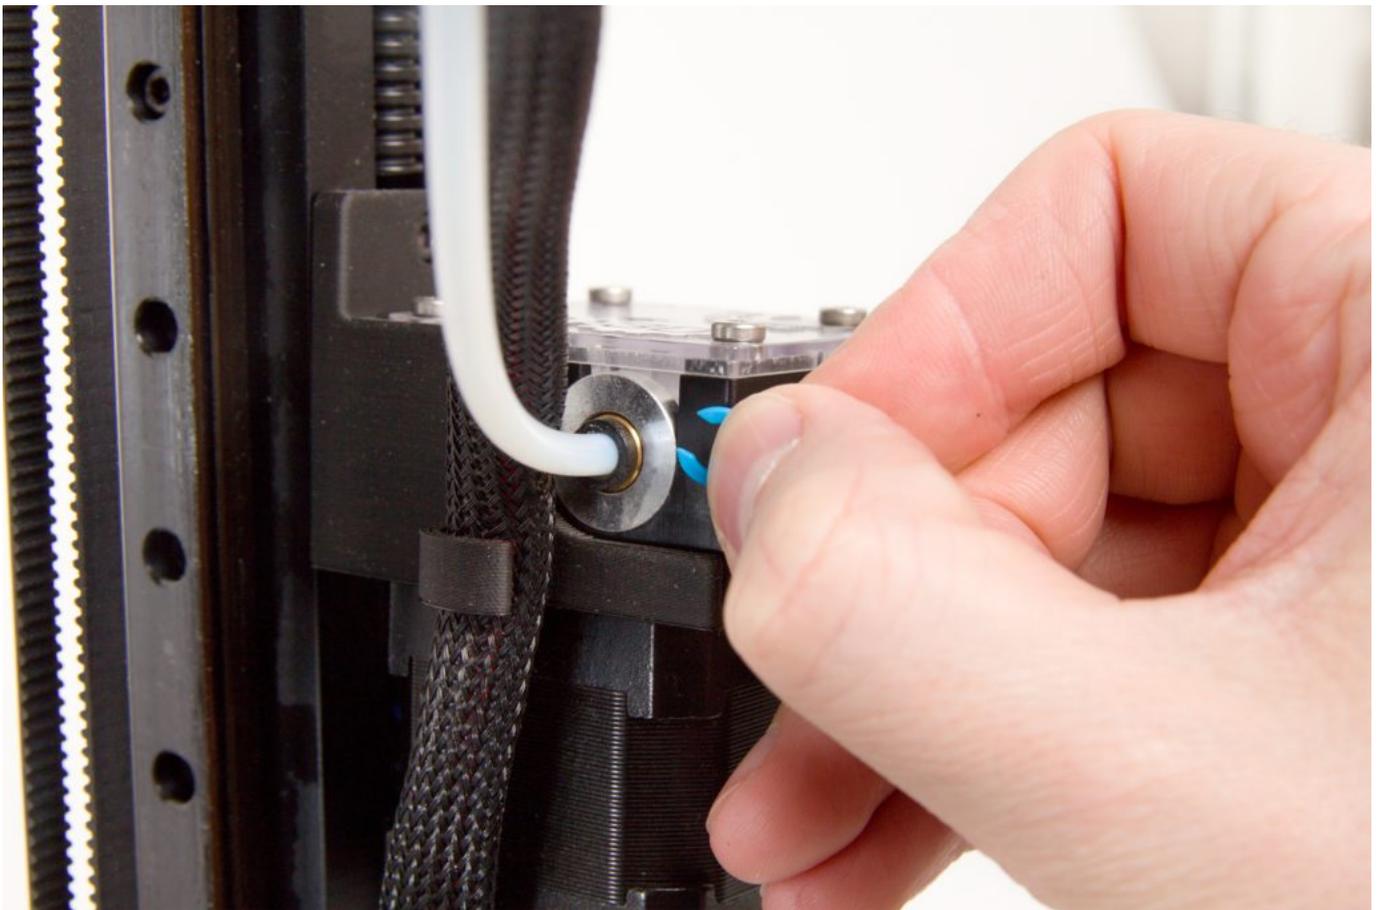
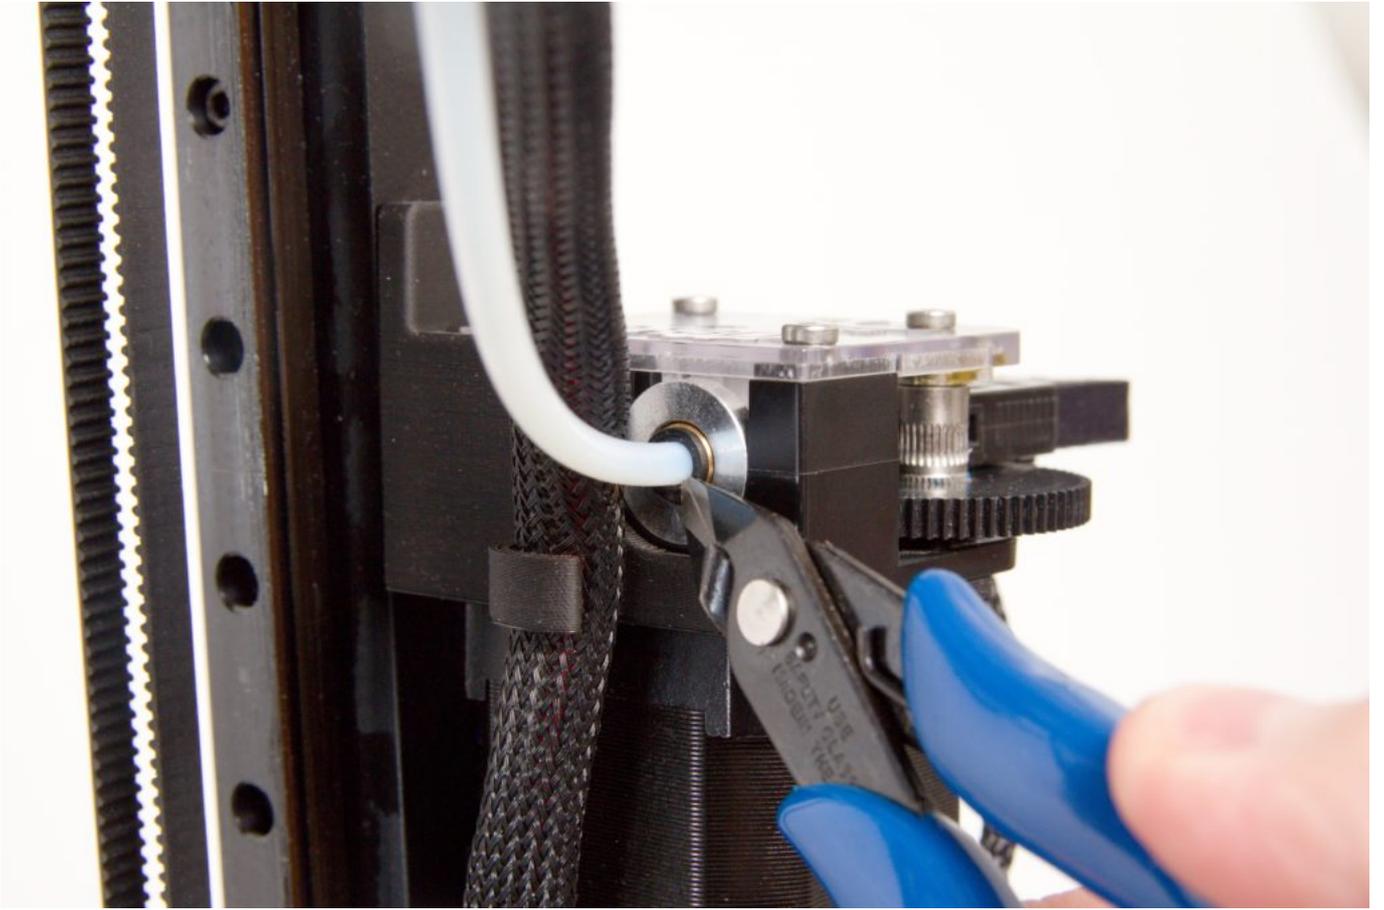
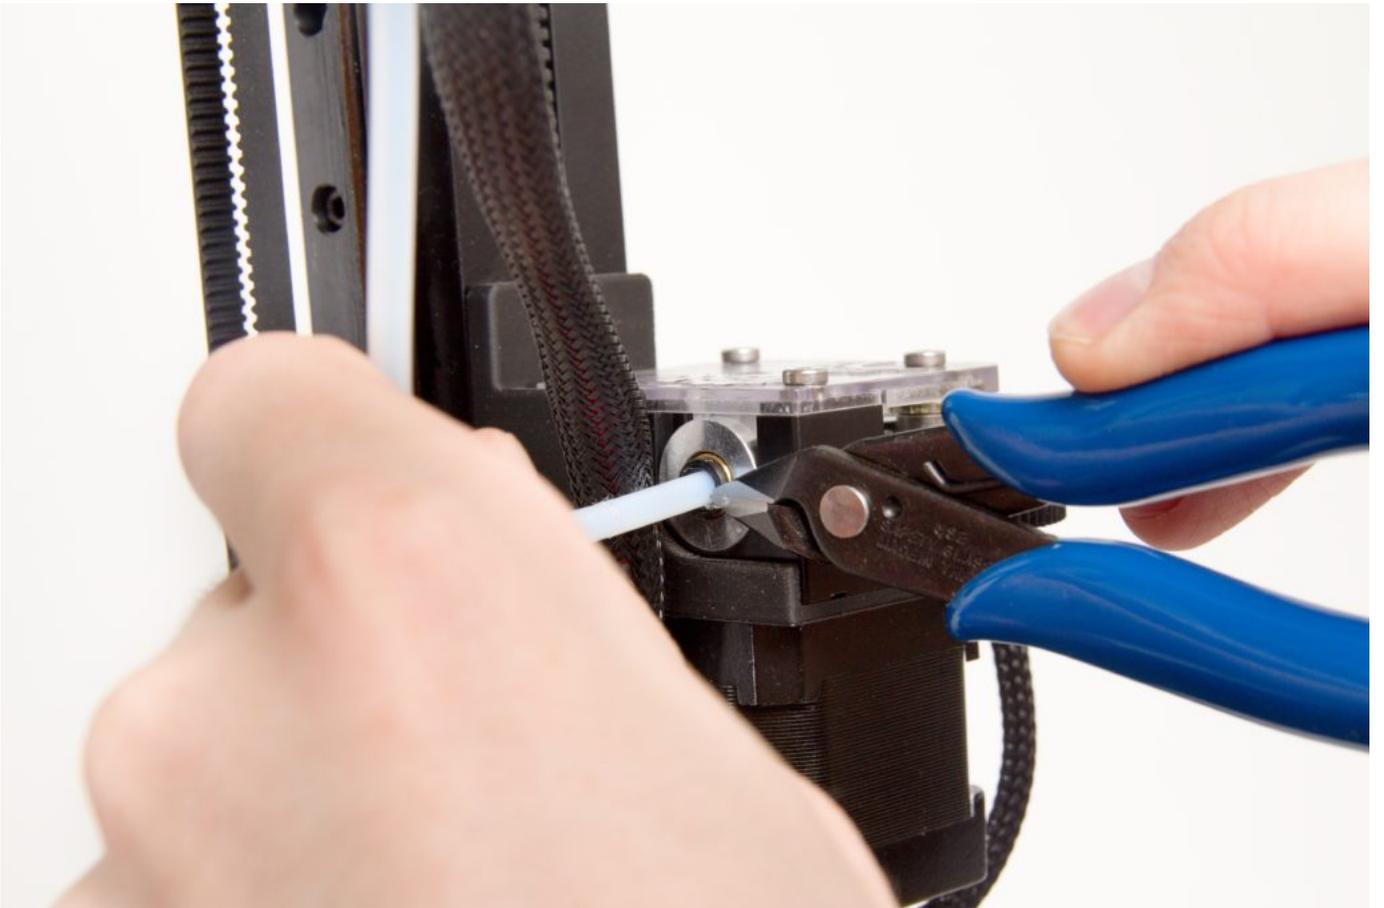
How to Remove the Bowden Cable from the Extruder

You can use your fingers or pliers to apply pressure on the black collet ring. However, make sure not to damage the bowden tube with the pliers.

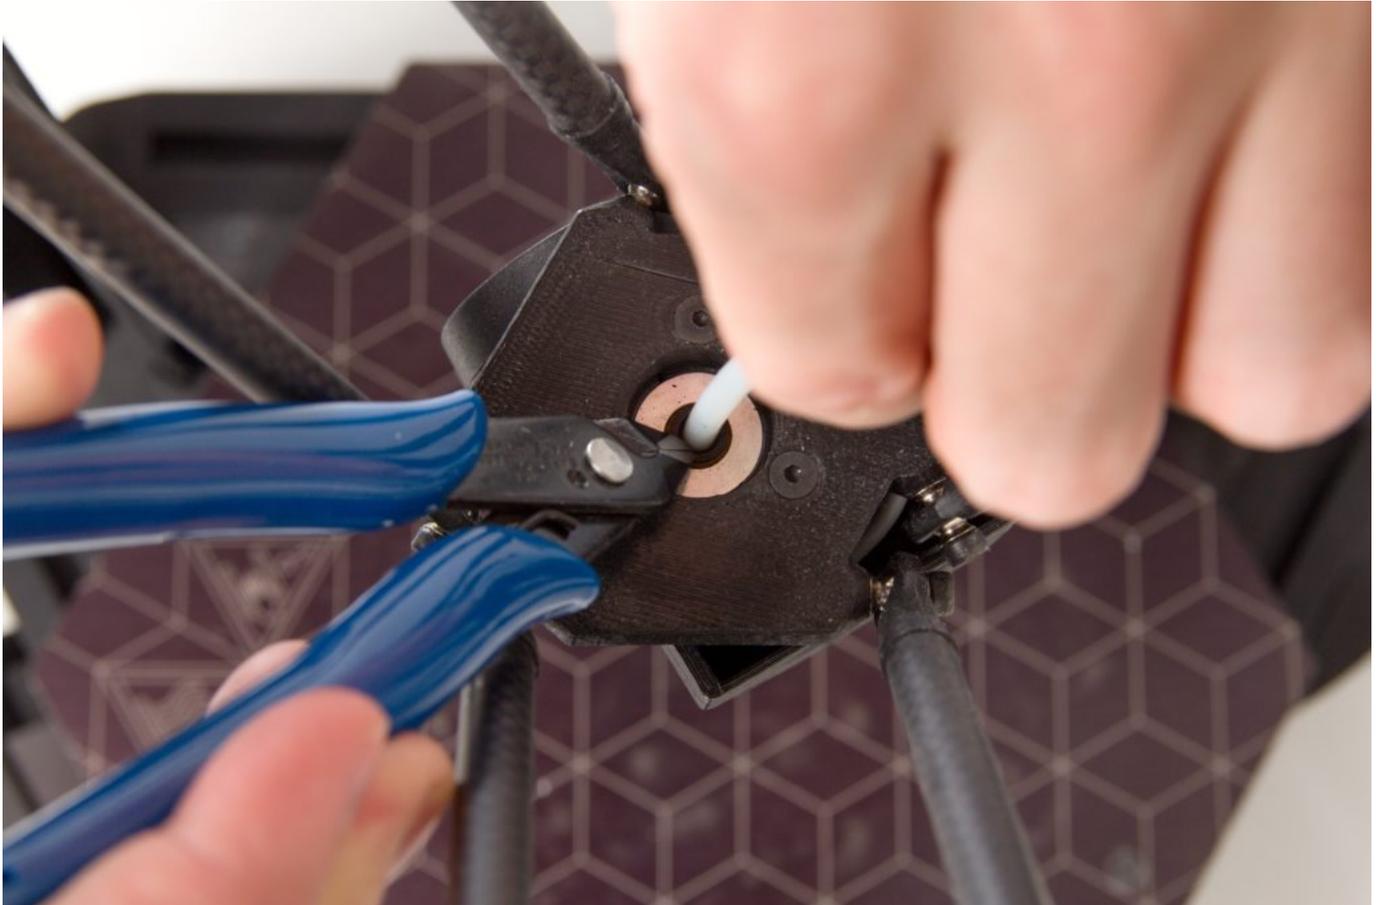
How to Remove the Bowden Cable From the Print Head

Perform the Removing the Filament steps, including the cooling down of the print head. Press on the black securing ring with the supplied wire cutters. The pressure on the Bowden cable will be released while you are pressing on this ring.

Remove the Bowden cable from the print head.

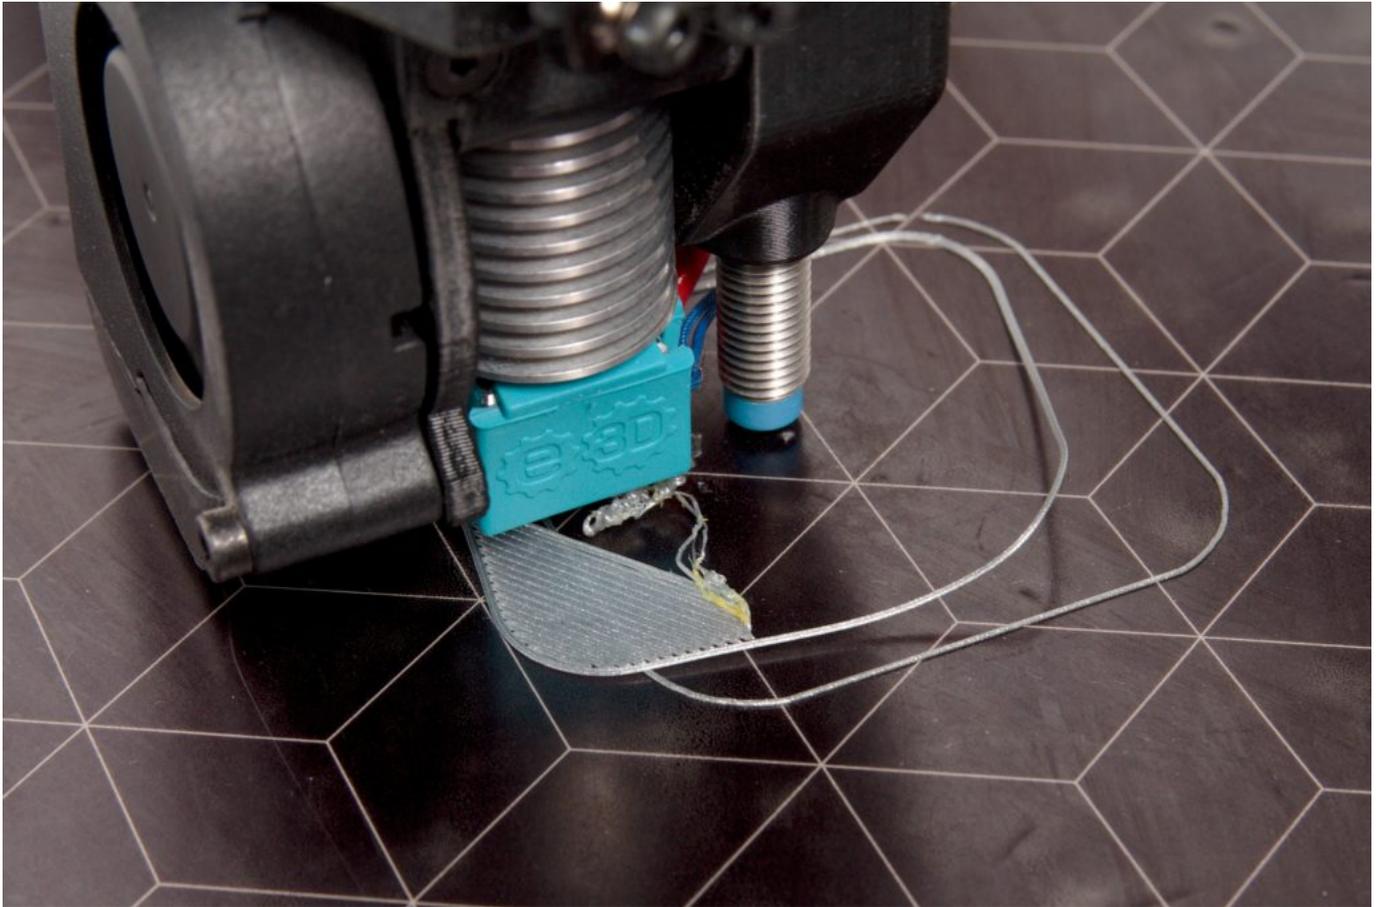
The First Layer Has Insufficient Adhesion

Outside of improper printing temperatures, the most common problem here lies in poor removal of grease from the base. In this situation, prepare the base thoroughly, following the Pre-print Base Preparation instructions.

If this has not solved the problem, then the trouble may be that the first layer is too high. The material is thus not sufficiently in contact with the base during printing, and is not holding in place.

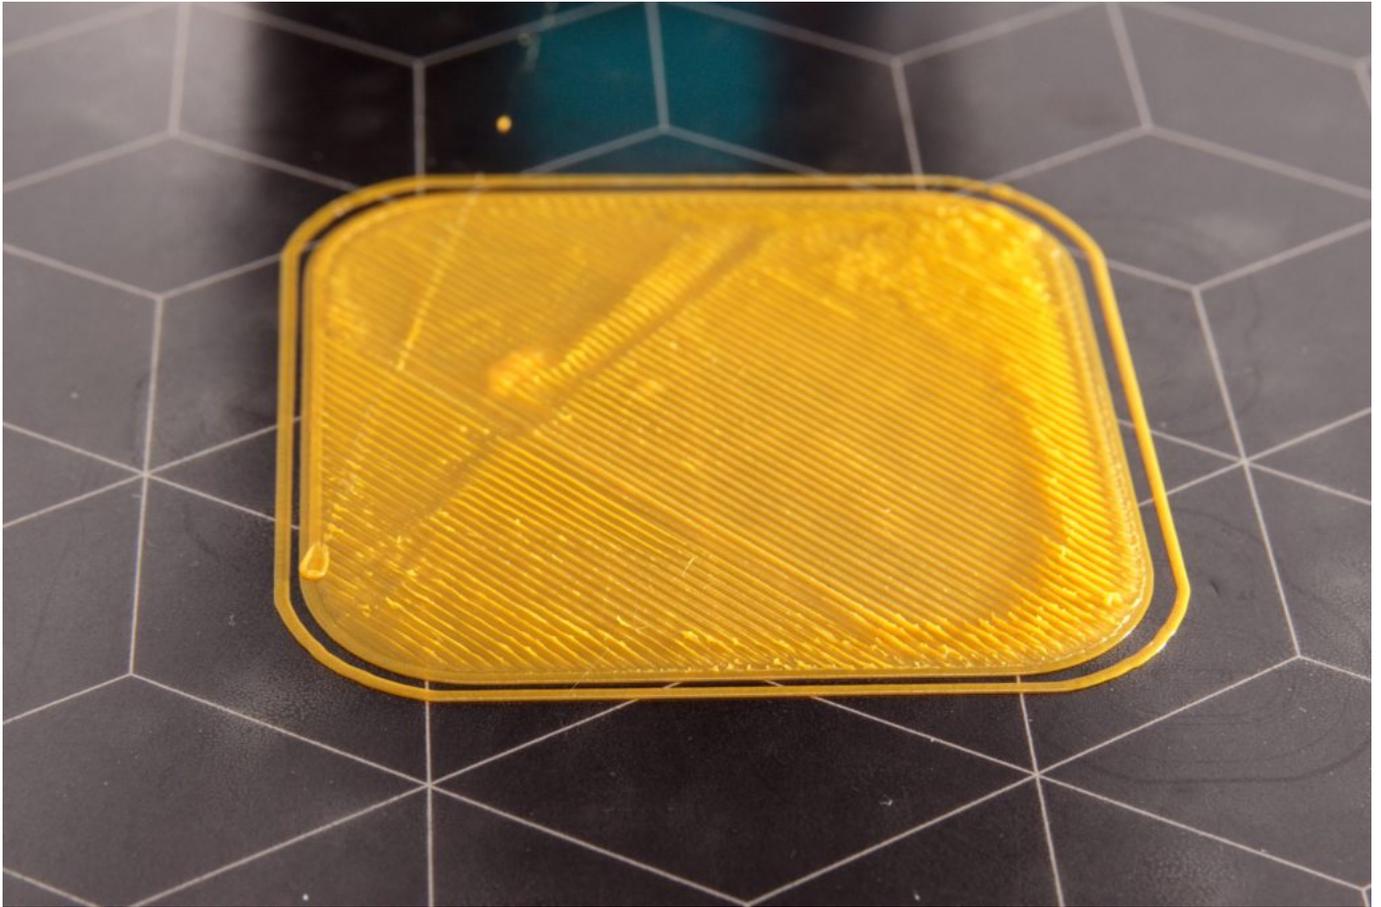
The First Layer Has Excessive Adhesion

The first possibility is that you used a material that naturally adheres very strongly to the PEI base (PET-G or CPE) without properly preparing the base beforehand. Please pay close attention to the procedures described in the Pre-print Base Preparation chapter.

The second possibility is that the first layer is too low. Here the solution is to raise the first layer. Proceed according to The First Layer Has Insufficient Adhesion above. However, here you will be adding to the Z-babystep value and then lowering the Z-probe-hgt value by the same value that you added in Z-babystep.

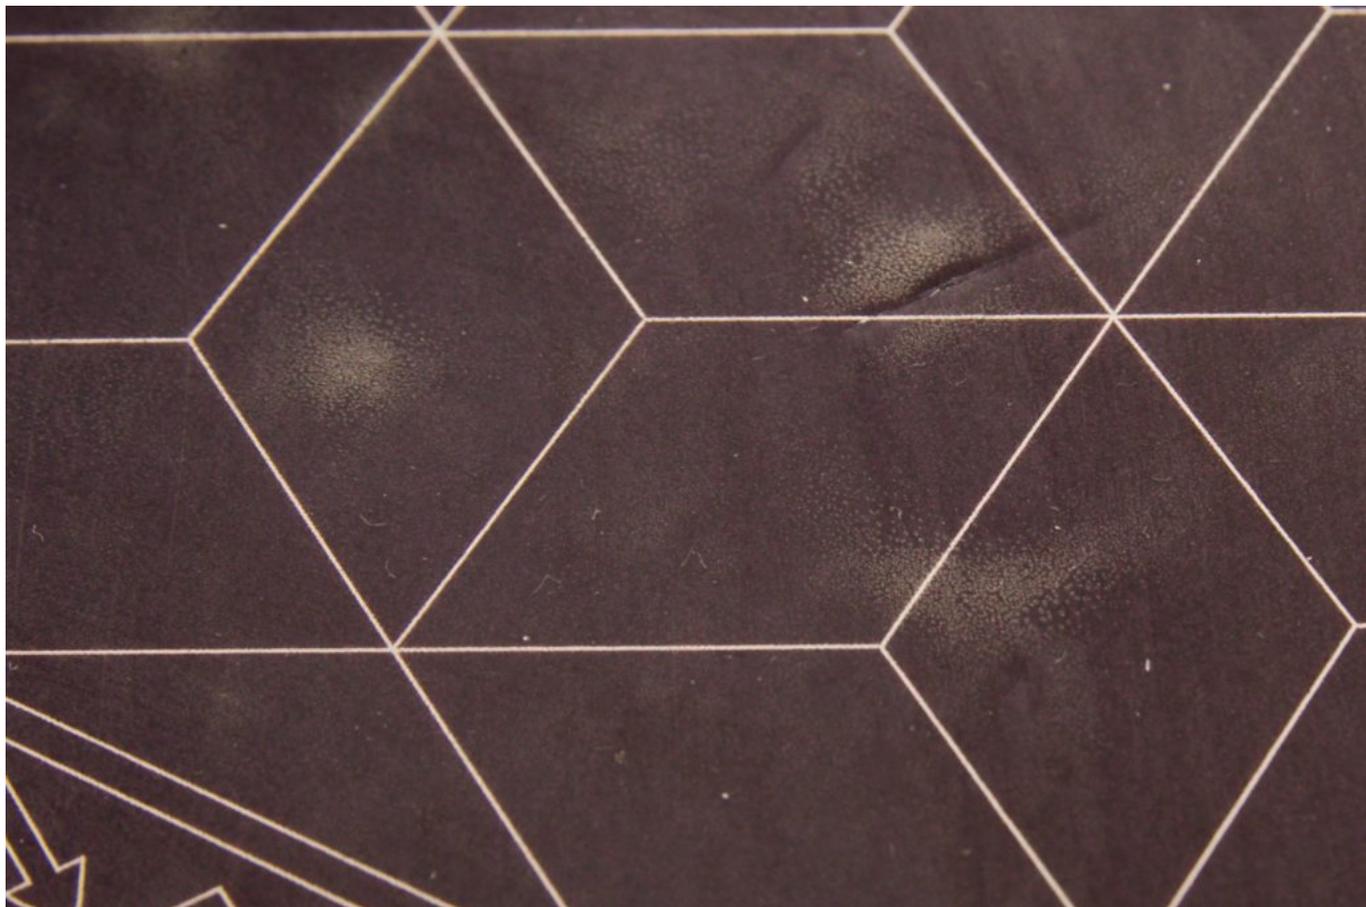
Bubbles or Light Spots Arise on the Printbed

These are naturally occurring glue bubbles that appear after heating and especially after repeated printing on the same place. When the printer is being used correctly in accord with the manual, there is no need to worry about them; they will disappear on their own after some time.

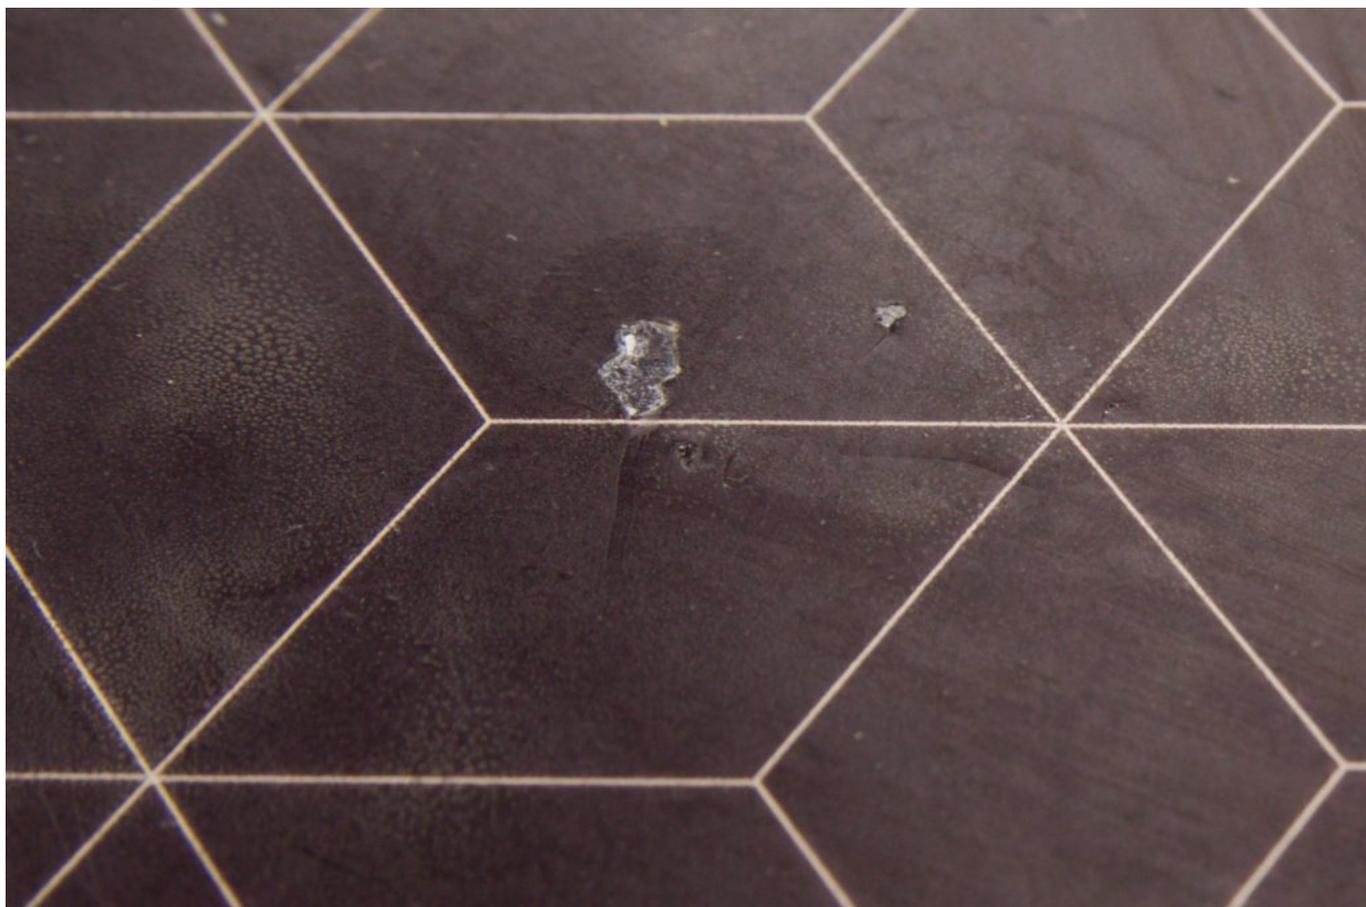
The Printbed Surface Is Damaged

Small scratches and nicks in the PEI base do not make the printer unusable. But if they become numerous or the damage becomes more extensive than this, contact our support team for a base replacement.
